## UPDATED ARBORIST REPORT Clayton Community Church *1027 Pine Hollow Court, Clayton CA*

*December 15, 2020*

Prepared For: Vander Heyden Architects, Inc.  
5506 Sean Circle #112  
San Jose CA 95123

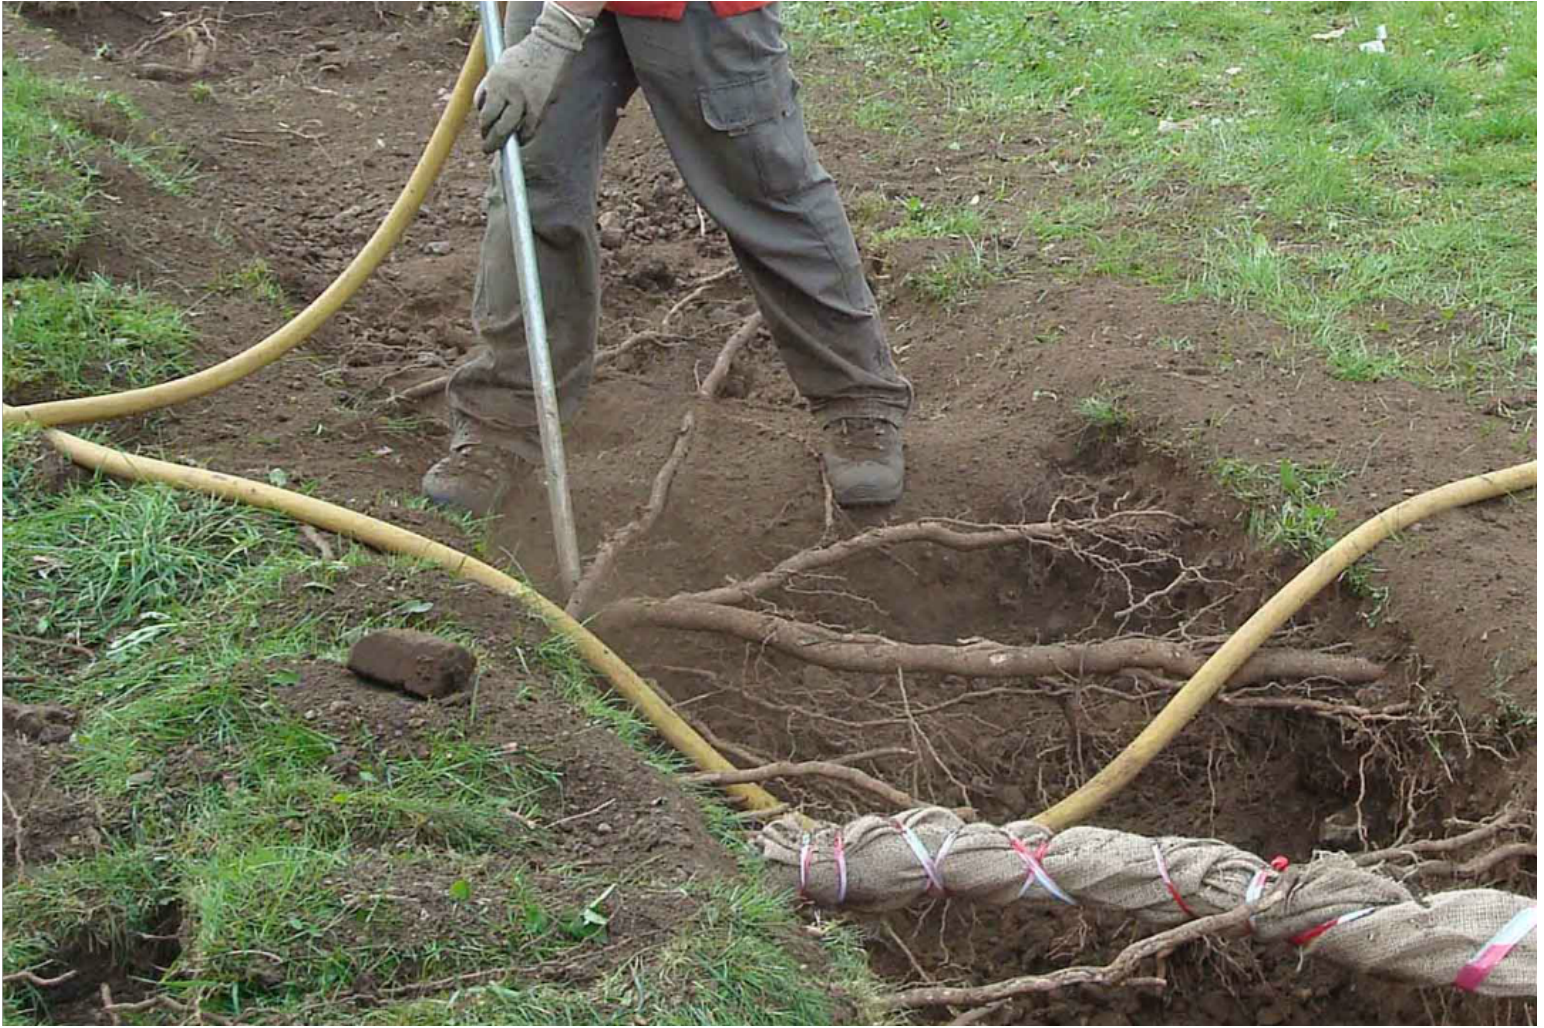
### 3. AIR SPADING & ROOT PRUNING

roots exposed by blowing away soil = air spading

**ROOT EXPOSURE & PRUNING:** Exposed & cut roots cleanly prior to work near tree to minimize damage to remaining roots and reduce the risk of causing disease, decay and instability.

- Expose roots along outside edge of 5 foot fenceline setback with air spade or other tool that uses compressed air
- Sharply cut completely and cleanly through all roots
- Use reciprocating saw with sharp blades or circular saws of varying types and/or a rotary-type stump grinder
- Saw blades or grinder teeth should be sharpened prior to use, and sharpness maintained
- Unless immediately backfilled after pruning, as a temporary measure, place burlap material and/or spread mulch over exposed roots after cuts are made and before soil is replaced. Keep this material damp until backfilled to prevent the fine roots from drying and dying
- Since root pruning occurs along or behind the line of planned construction, it should be coordinated with the tree protection fencing
